Property Inspection Report

1234 Sample Report Way, Virginia Beach, VA 23456
Inspection prepared for: Happy Client
Date of Inspection: 7/4/2016

Inspector: Troy Pappas
Bill Dazzo and Dustin Kineman

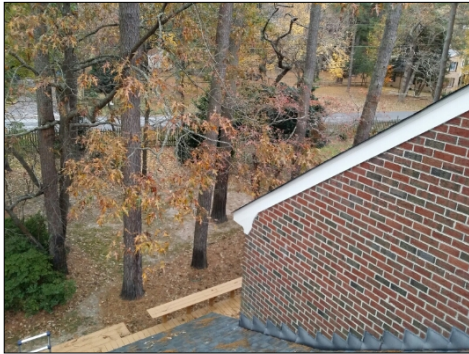
2.1. All trees limbs should be trimmed back to prevent damage and wear to roof.

Should be trimmed back

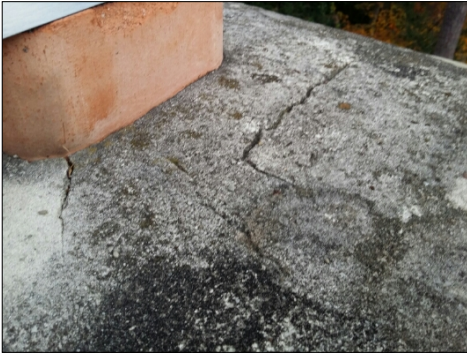
5.1. Maintenance needed at the chimney crown to prevent damage.

Chimney crown cracking

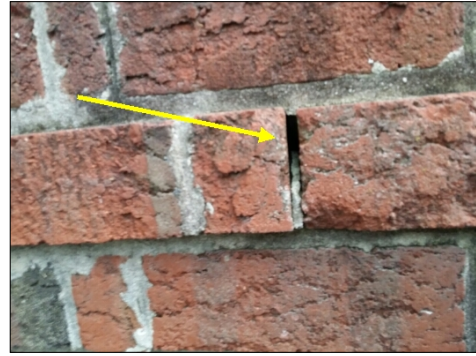
5.2. The chimney chase had area(s) where the mortar needed to be repointed.

recommend repointing

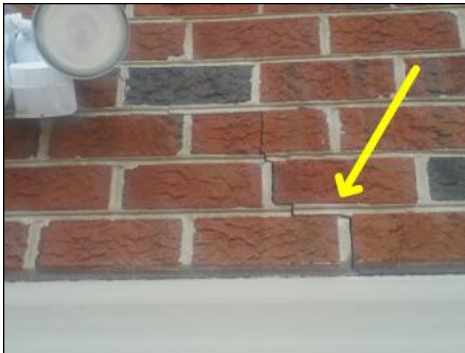
1.1. The cause of cracking at the brick veneer should be determined by a qualified contractor and be repaired as needed. Location: mainly above garage door and upper rear middle window

Cracked brickwork

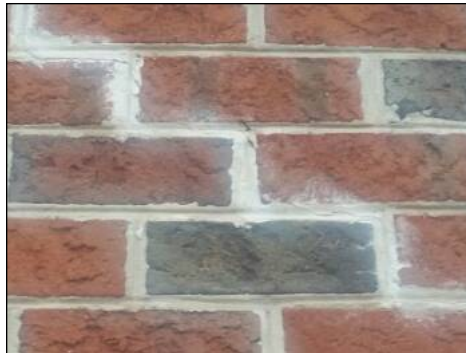
Cracked repairs

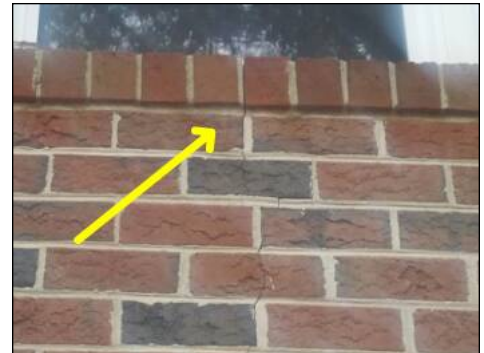
Cracked brickwork

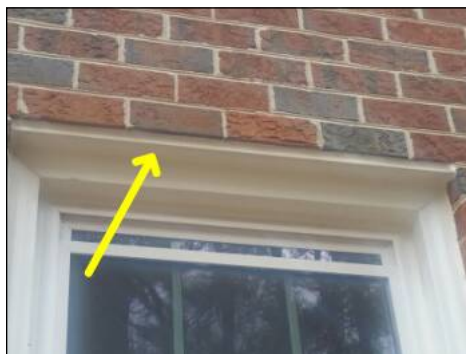
4.1. Sealant installed at the window lintels can trap water at the lintel causing rust and corrosion damage. You should have weep holes installed to allow moisture to exit.

No weep holes at sealant

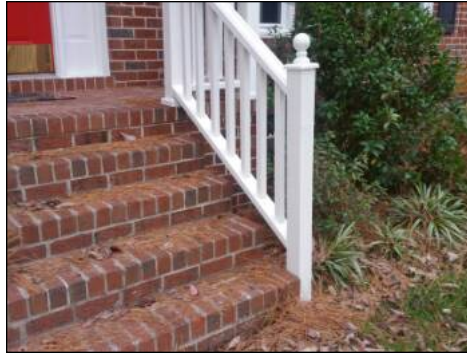
5.2. Loose component(s) should be repaired to provide safe conditions. Location: front right handrail

Loose handrail

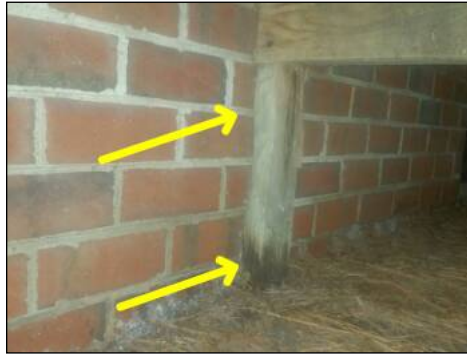
6.1. We recommend adding additional support to the 2x4's supporting the girders. There was some deterioration at the base of the current supports.

Recommend adding additional support for girders

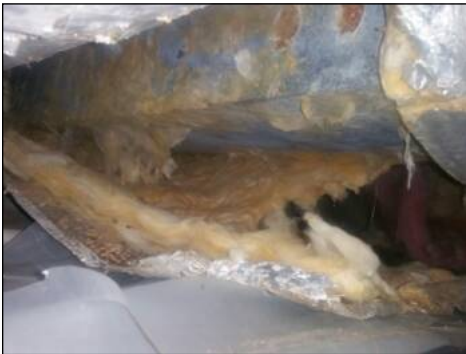
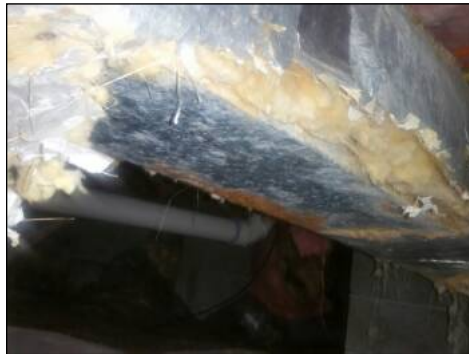
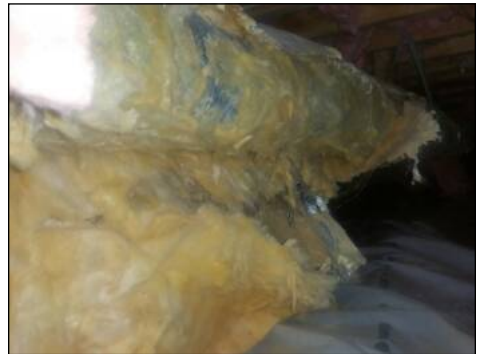
8.2. Damaged or loose ductwork insulation in the crawlspace should be repaired. Location: multiple locations

Insulation damaged at ductwork

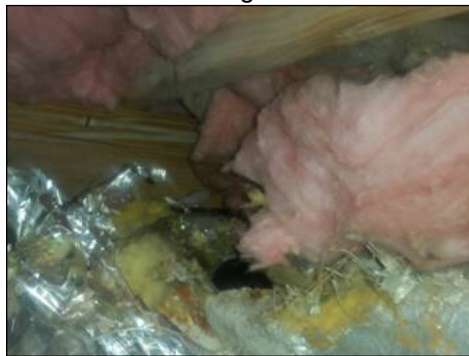
8.3. Disconnected ductwork in the crawlspace should be properly reconnected. Location: left side middle crawlspace

Disconnected ductwork

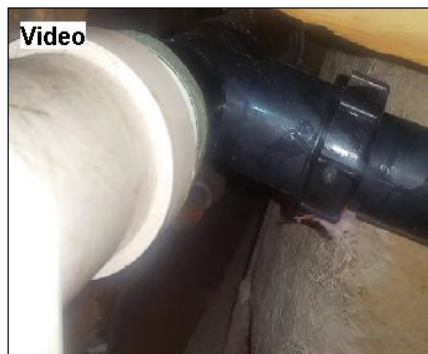
CLICK to view VIDEO - leaking under downstairs tub

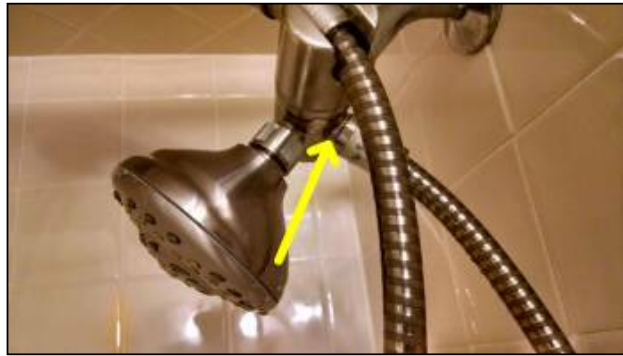
11.2. Leaking shower heads should be tightened or sealed to prevent moisture damage. Location: upstairs hall bathroom

Leaking shower head

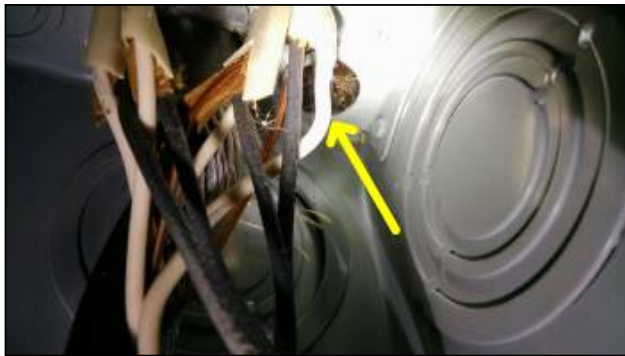
3.2. All **unfilled knockouts** in the main electrical panel should be properly covered.

Open knockouts

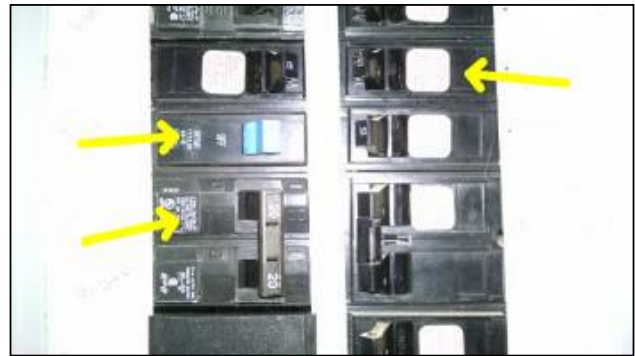
3.1. Although the installed breakers not listed by the **panel manufacturer** fit the panel we recommend they be verified they are classified for this panel.

Different brands of breakers

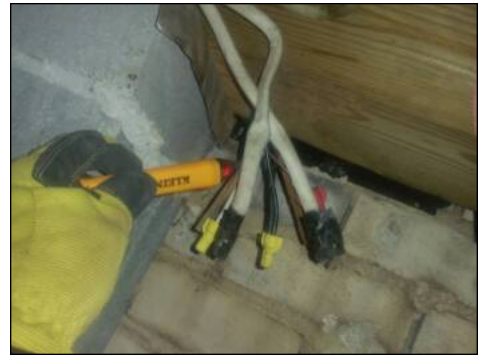
Wiring should be in a junction box

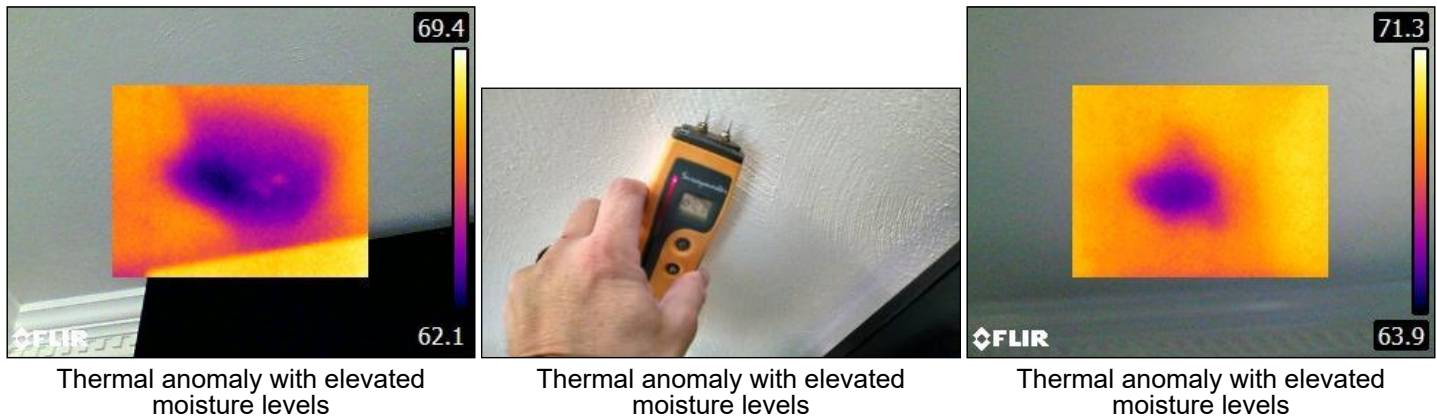
4.1. **Moisture stains** at the ceiling had elevated moisture levels, the source of moisture should be located, and all necessary repairs made. Location: Living Room Ceiling

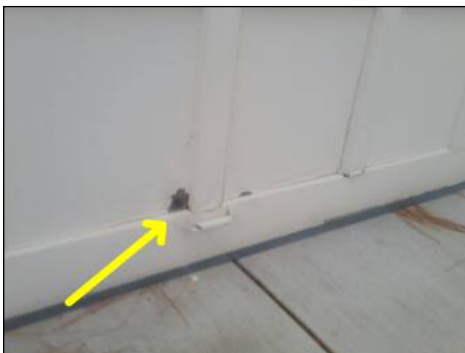
- 2.1. There was physical damage to the garage door. Although the door was functioning the damage may cause the door to fail and repair or replacement is advised.
 2.2. FYI: You will need to obtain the code from the seller to determine if the outdoor keypad is operational.
 2.3. FYI: The manual garage door lock should be disabled to prevent it from being locked and potentially damaging the door when operating the automatic opener.
 2.4. There was physical damage to the garage door. Although the door was functioning the damage may cause the door to fail and repair or replacement is advised.

Damage at garage door

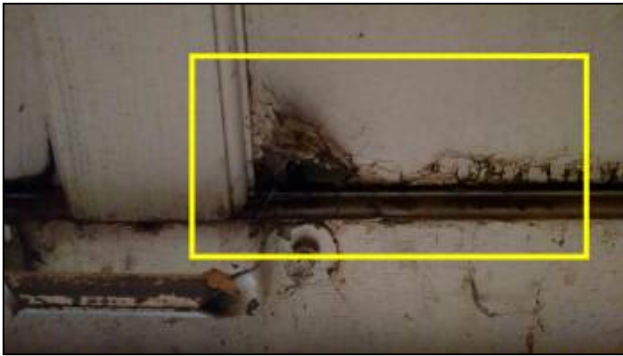
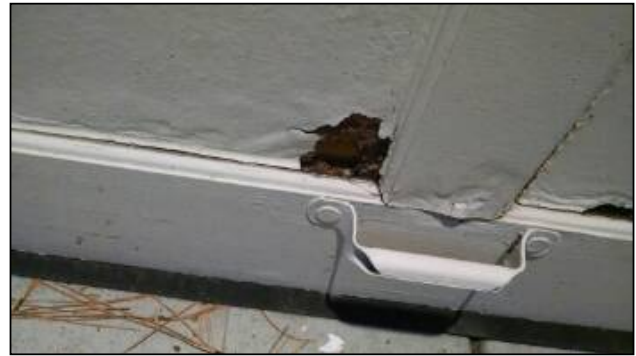
Moisture damage at door

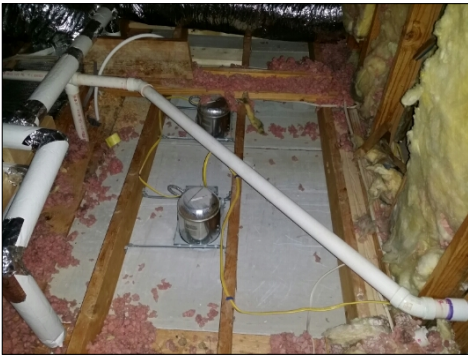
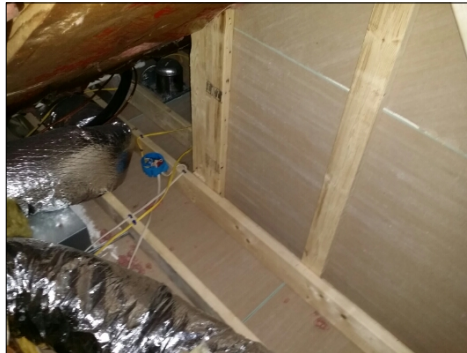
3.3. Insulation should be installed at all missing areas in attic.

Areas missing insulation

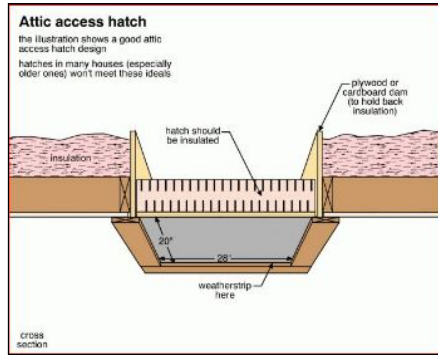
Insulating all attic accesses is recommended

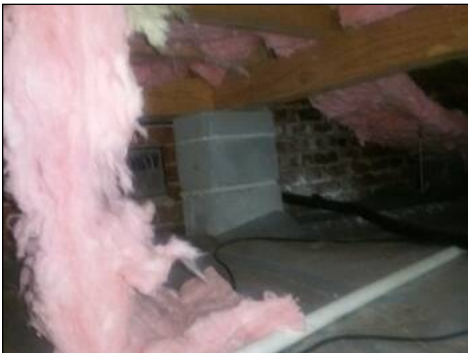
2.1. Loose insulation should be repaired or replaced as needed.

Falling insulation

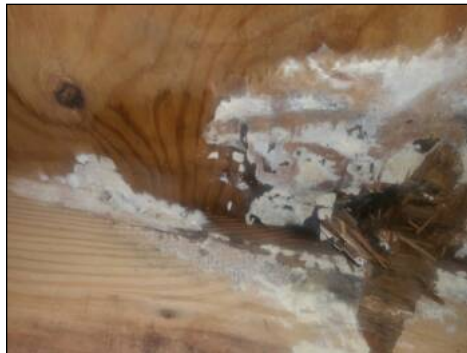
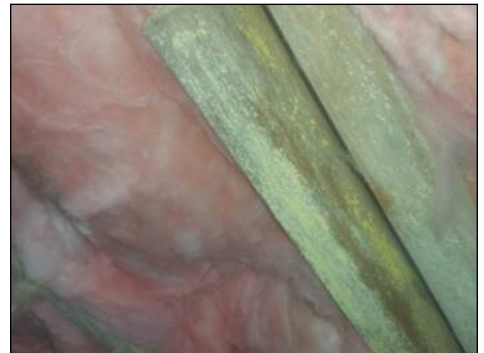
2.2. **Biogrowth** indicates a current or prior moisture issue. A professional moisture contractor should evaluate for any needed repair or remediation.

Biogrowth observed

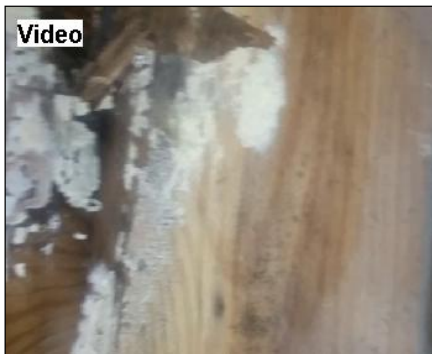
3.2. Moisture damage had elevated levels of moisture indicating that the moisture intrusion was recent. The source of this moisture should be determined, repairs made, and any associated damage corrected. Location: both rear exterior doors to deck

CLICK to view VIDEO - example of damage below doors

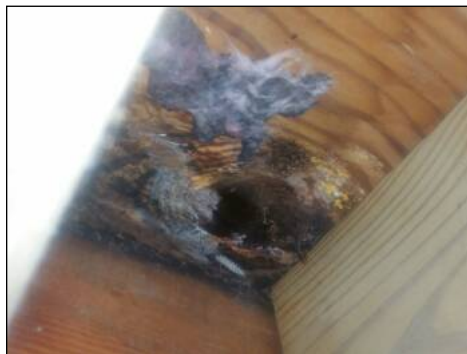
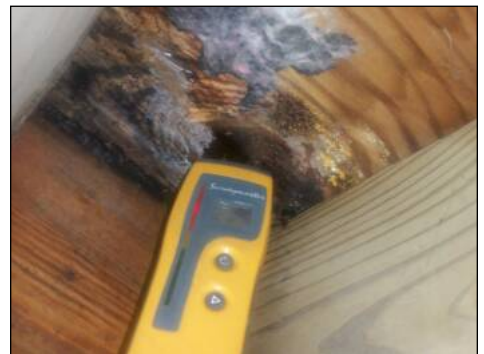
Elevated moisture observed

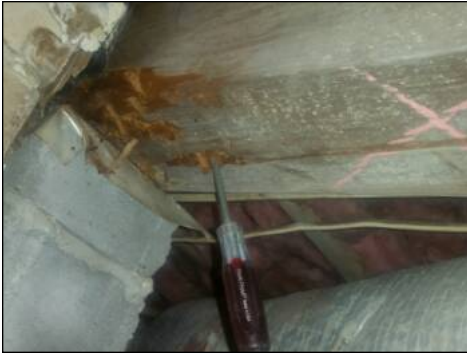
Damage at beam(s)

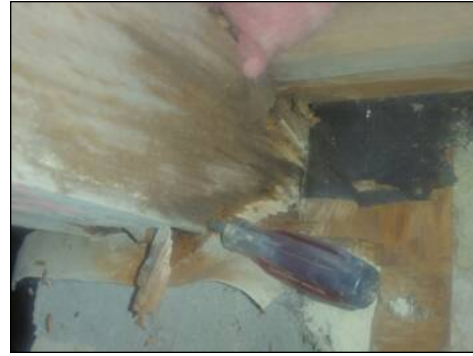
3.1. All wood damaged by biogrowth should be evaluated by a professional moisture inspection company to remediate as needed. Location: Rear left middle crawlspace multiple areas

Wood damage due to biogrowth
