Property Inspection Report

1234 Sample Report Way, Virginia Beach, VA 23456
Inspection prepared for: Happy Client
Date of Inspection: 7/4/2016

Inspector: Troy Pappas
Bill Dazzo and Dustin Kineman

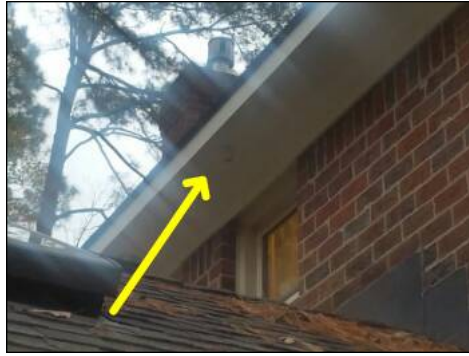
7.1. FYI: **Auxiliary condensate drain** termination location: rear soffit

FYI: Auxiliary condensate drain location

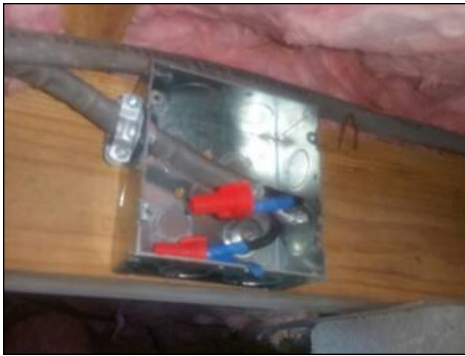
4.2. Open junction boxes should have covers installed. Location: Rear middle and multiple at middle left side of crawlspace and right rear attic

Junction boxes should have covers

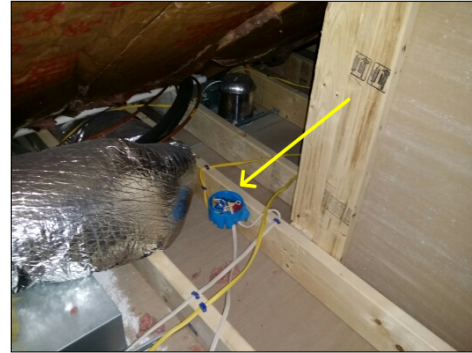
Junction boxes should have covers

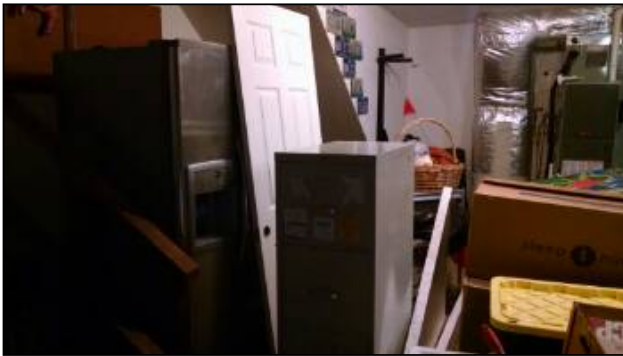
1.1. FYI: The majority of the garage wall was not accessible to view for penetrations. If there are any penetrations between the garage and house it is recommended they be appropriately sealed.

Storage limits visual inspection

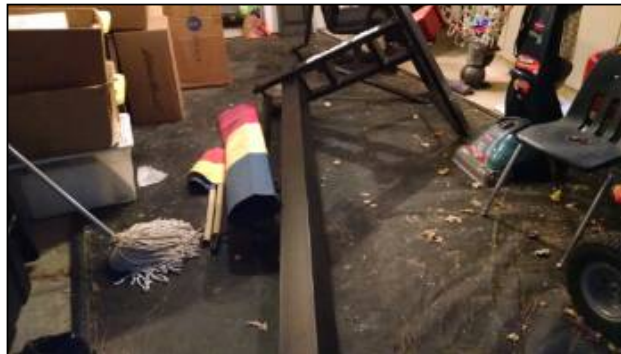
4.1. There was a tarp over the garage floor. The tarp would need to be removed to determine condition of the garage floor.

Floor covered with tarp

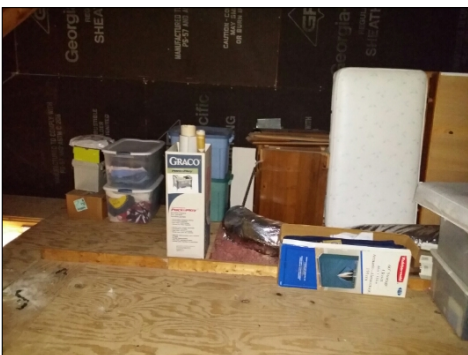
2.1. FYI: While we make every effort to find areas of concern, some areas can go unnoticed when there is a large amount of personal storage. The inspection did not involve moving personal belongings or furniture.

Storage limits visual inspection

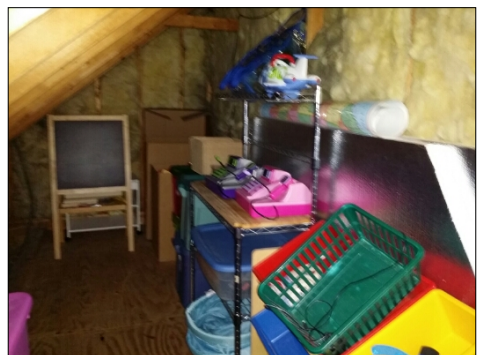
Storage limits visual inspection
