Property Inspection Report

1234 Sample Report Way, Virginia Beach, VA 23456
Inspection prepared for: Happy Client
Date of Inspection: 7/4/2016

Inspector: Troy Pappas
Bill Dazzo and Dustin Kineman

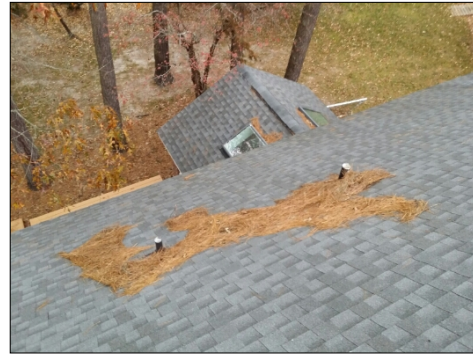
2.2. Improve: Debris on the roof should be cleared to prevent moisture issues.

Clear debris

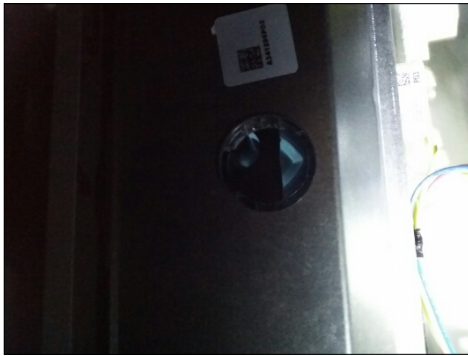
4.1. The heating system functioned. We recommend inquiring about the systems service record.

Functional

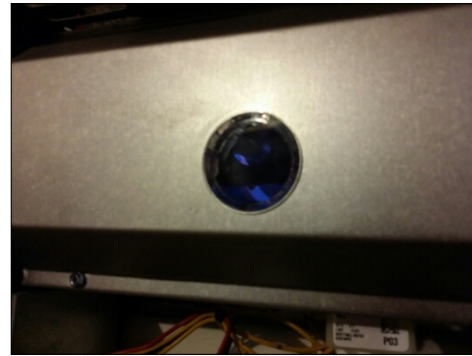
Functional

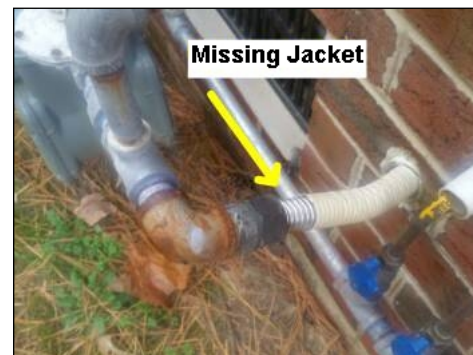
13.1. There was no additional bonding observed for the corrugated stainless steel (**CSST**) gas piping which is required by the manufacturer and should be corrected. Exposed pipe should be properly protected as well.

No additional bonding for CSST

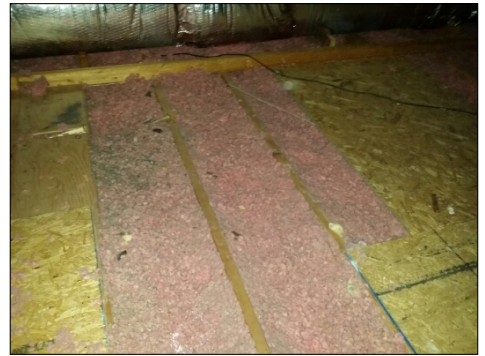
Approximately 4 - 7 inches

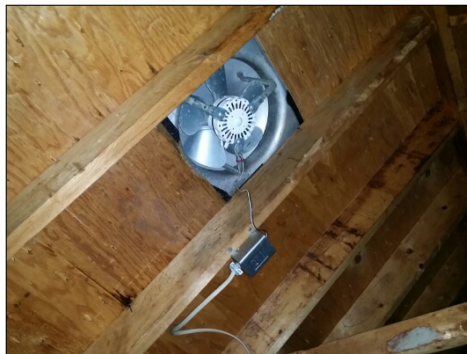
4.1. FYI: The powered ventilator fan could not be tested due to being inaccessible.

inaccessible

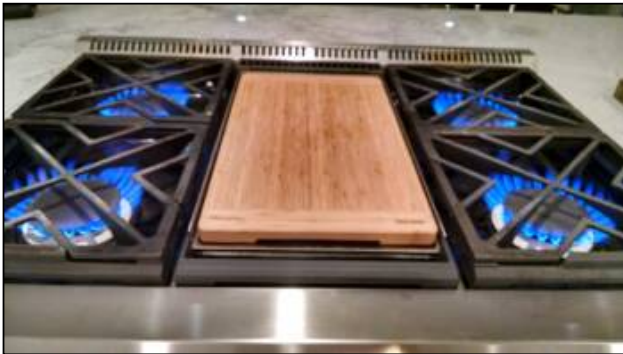
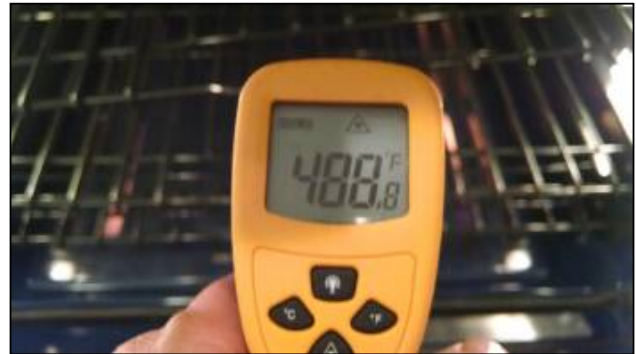
1.2. The heating elements/burners and oven operated when tested, but does not confirm the efficiency of the system.
